DEPARTMENT OF TRANSPORTATION**DIVISION OF ENGINEERING SERVICES**

Quality Assurance and Source Inspection

Contract #: 04-0120F4Cty: SF/ALA Rte: 80 PM: 13.2/13.9File #: 69.28**WELDING INSPECTION REPORT****Resident Engineer:** Siegenthaler, Peter**Address:** 333 Burma Road**City:** Oakland, CA 94607**Report No:** WIR-019730**Date Inspected:** 10-Jan-2011**Project Name:** SAS Superstructure**OSM Arrival Time:** 700**Prime Contractor:** American Bridge/Fluor Enterprises, a JV**OSM Departure Time:** 1900**Contractor:** Zhenhua Port Machinery Company, Ltd (ZPMC), Changxing Island **Location:** Shanghai, China**CWI Name:** Qiu Wen.**CWI Present:** Yes No**Inspected CWI report:** Yes No N/A**Rod Oven in Use:** Yes No N/A**Electrode to specification:** Yes No N/A**Weld Procedures Followed:** Yes No N/A**Qualified Welders:** Yes No N/A**Verified Joint Fit-up:** Yes No N/A**Approved Drawings:** Yes No N/A**Approved WPS:** Yes No N/A**Delayed / Cancelled:** Yes No N/A**Bridge No:** 34-0006**Component:** OBG components.**Summary of Items Observed:**

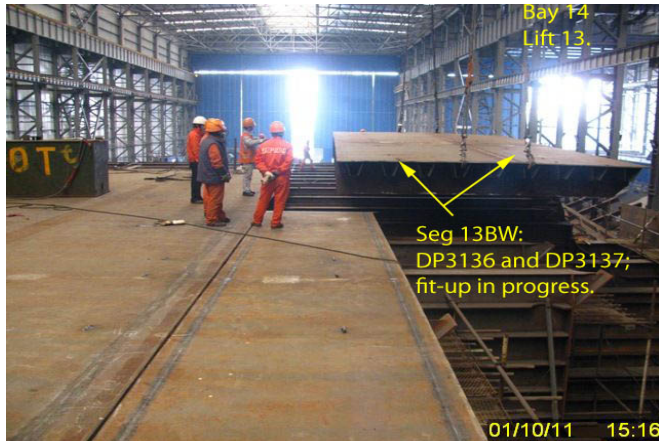
This QA Inspector observed that fit-up of Deck Panels (DP3136 and DP3137) with Seg 13BW is in progress. See attached photo for further information.

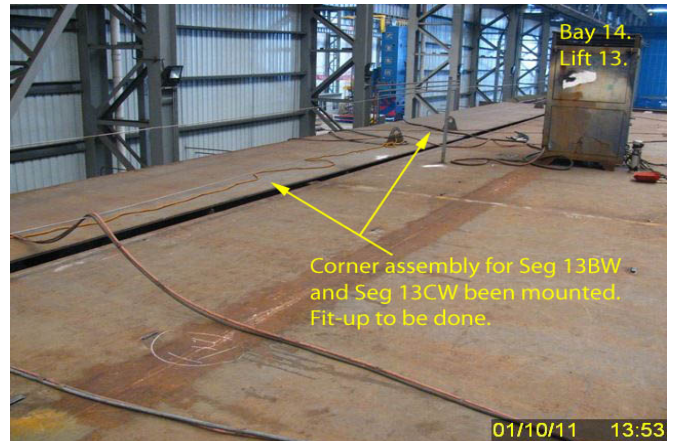
This QA Inspector observed that the Corner Assemblies (W4 – cross Beam Side) for Seg 13BW and Seg 13CW are mounted on the respective segments. Fit-up is to be done. See attached photo for further information.

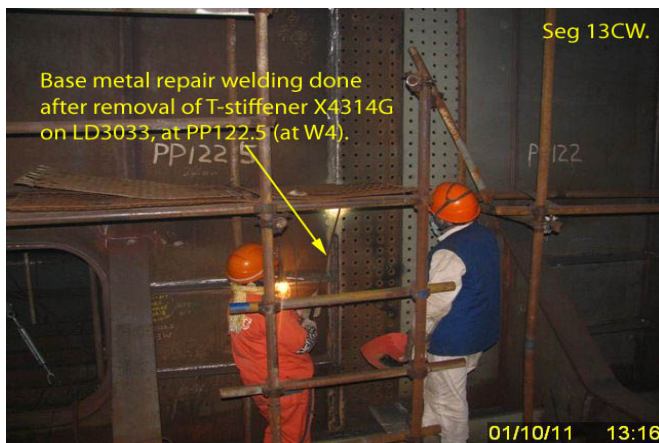
ZPMC personnel performing base metal repair welding on Longitudinal Diaphragm (LD) 3033A and LD 3036A at PP122.5. The welder is identified as 045196 and was observed welding in the 3G position. Welding process was identified as SMAW. ZPMC QC was identified as Wang Xiang Ping. Repair welding was done as per WRR: 19640 Rev-0. Base metal repair welding was done after the removal of T-stiffeners; X4314G (at W4) and X4349D (at W3). T-stiffeners were needed to be removed to perform alignment and drilling of splice plate at PP122 – PP122.5. See attached photo for further information.
